**CWA COMPLIANCE EVALUATION INSPECTION REPORT
U.S. ENVIRONMENTAL PROTECTION AGENCY, REGION 5**

Meadowlark Dairy, LLC

NPDES Permit Number: WI-0061905-04-0

Date of Inspection: November 21, 2019

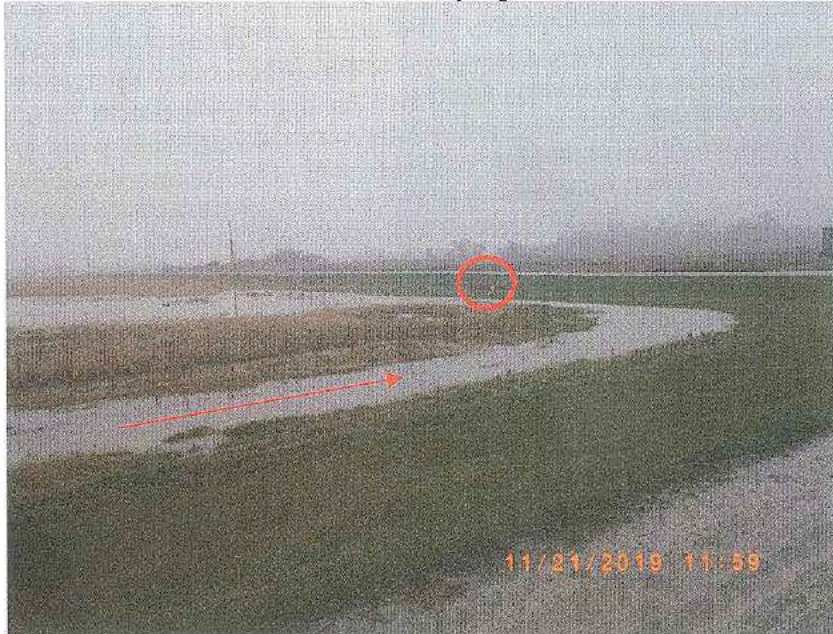
1: IMGP0001

Description: The West Stormwater Ditch on the west side of the South Site conveys flow by gravity to the north as shown by the red arrow. The water within the West Stormwater Ditch flows by gravity through the culvert inlet (within the red circle) to the north side of Meadowlark Road.

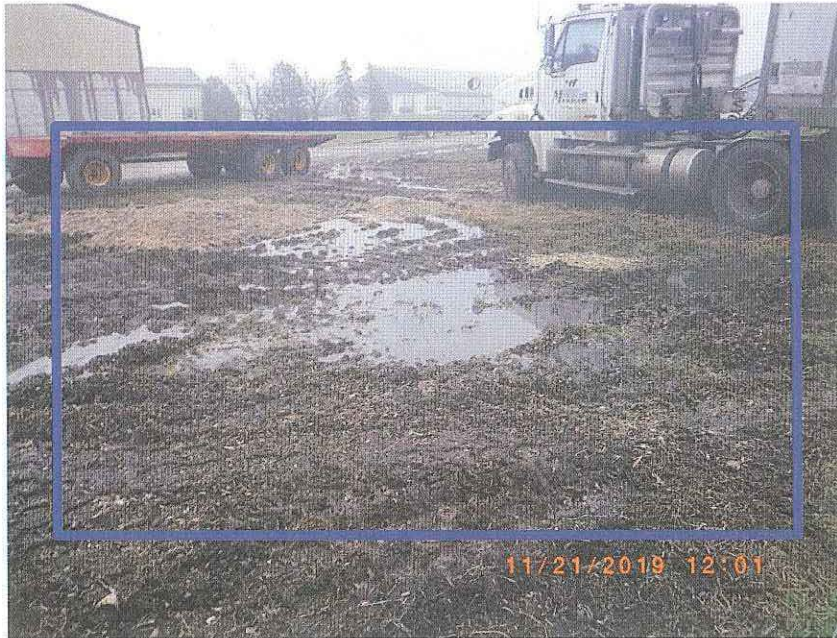
5: IMG0005

Description: In the blue box is feed that has spilled or had been dumped on the ancillary areas south of the Silage Bunkers on the west side of the North Site.

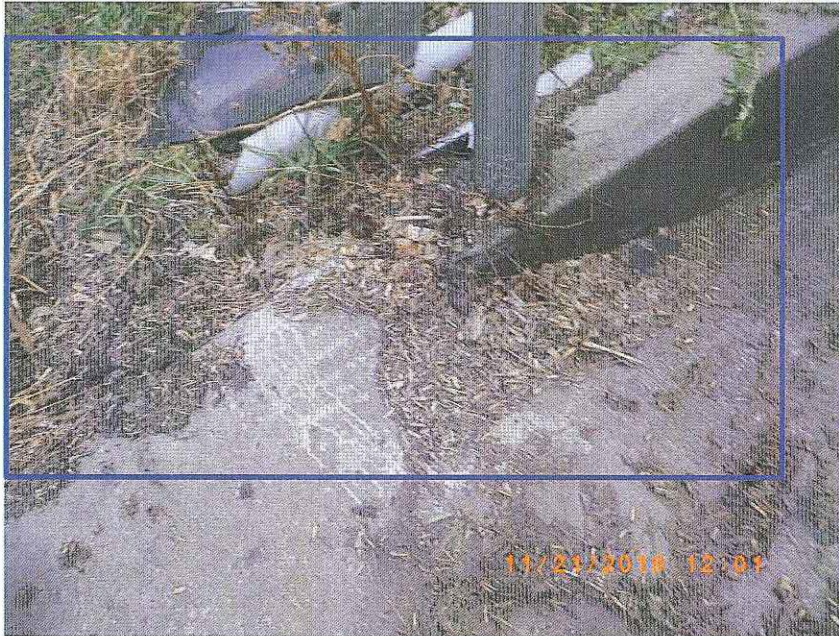
6: IMGP0006

Description: Feed washed off the concrete pad at the southeast corner of the Collection Pit. The feed is in the blue box in the photo above.

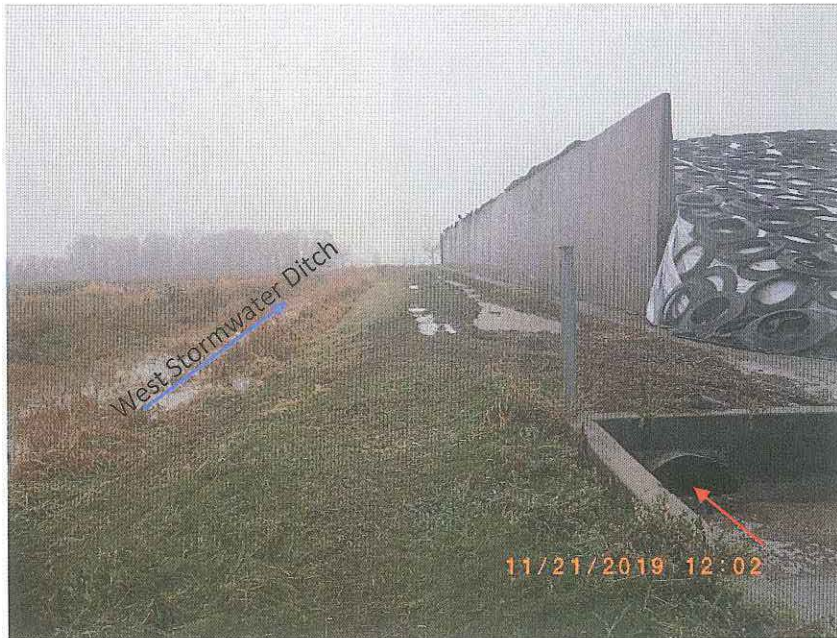
7: IMGP0007

Description: The red arrow shows the direction of flow of process wastewater collected in the Collection Pit as it flows through the culvert inlet into the underground pipe that conveys the process wastewater flow by gravity through a culvert outlet into the Concrete Channel south of the VTA.

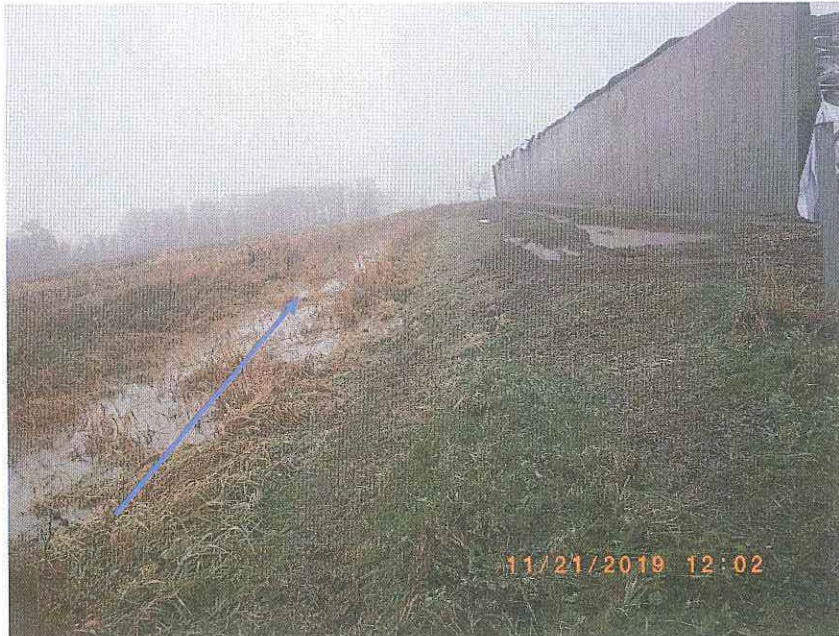
9: IMGP0009

Description: The blue arrow shows the stormwater flow in the West Stormwater Ditch from the South Site through a culvert under Meadowlark Road that outlets on the North Site. The stormwater continues to flow by gravity in the West Stormwater Ditch along the west side of the North Site to the north.

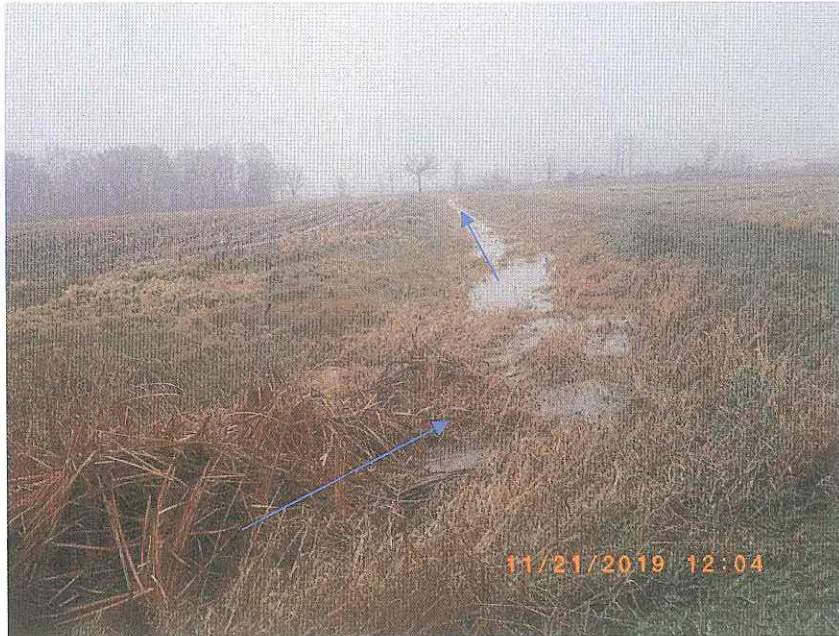
11: IMGP0011

Description: The West Stormwater Ditch located on the west side of the VTA flows by gravity to the unnamed tributary of the Fox River.

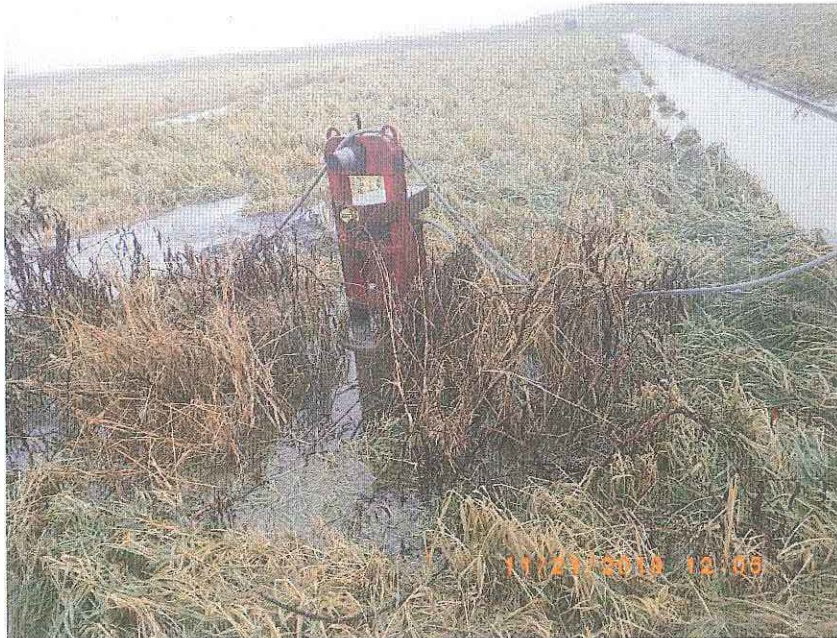
13: IMGP0013

Description: The process wastewater in the Concrete Channel, south of the VTA, flows by gravity out of the Concrete Channel to the northwest toward the pump. The pump is designed to collect the 1st flush of process wastewater coming out of the Concrete Channel and into the VTA. The first flush is pumped into Pit 2. The remaining process wastewater is dispersed by gravity through the VTA.

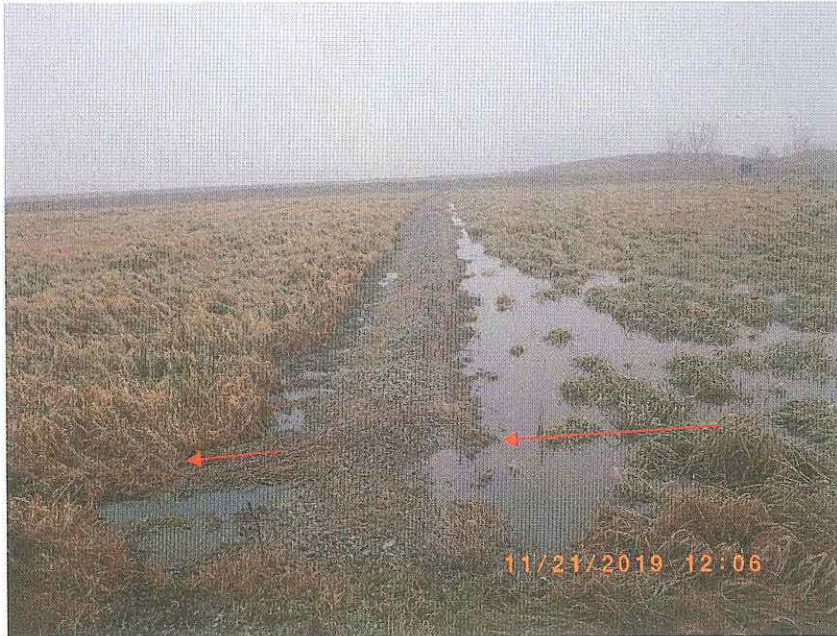
15: IMGP0015

Description: The 2nd spreader bar within the VTA. The red arrows show the direction of flow of process wastewater within the VTA (flows north).

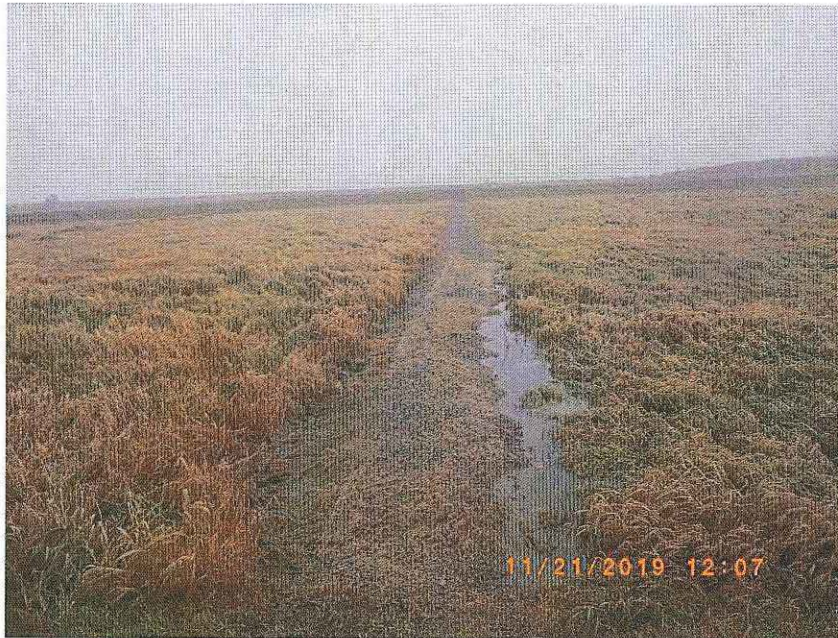
16: IMGP0016

Description: The 3rd spreader bar within the VTA. The most of the process wastewater was held back by the 3rd spreader bar.

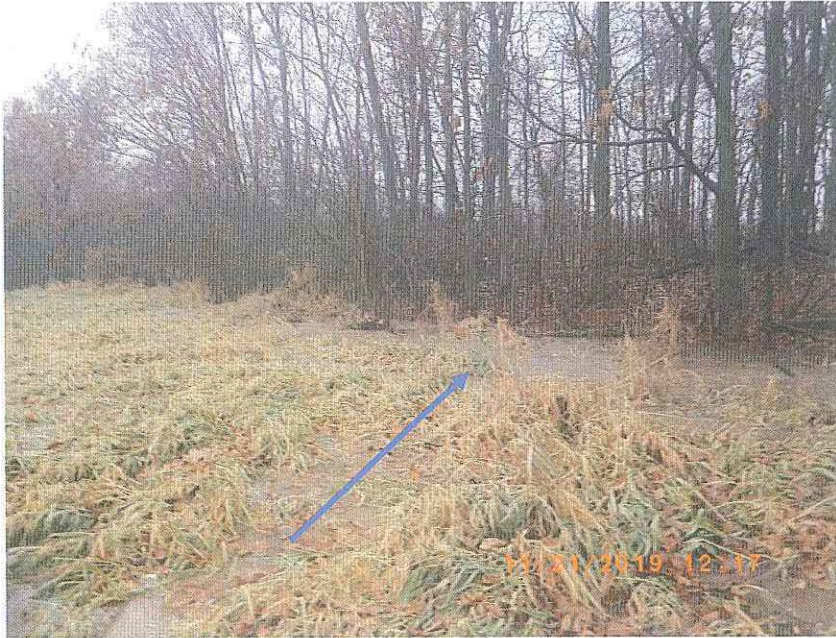
19: IMGP0019

Description: The West Stormwater Ditch was flowing into the unnamed tributary of the Fox River.

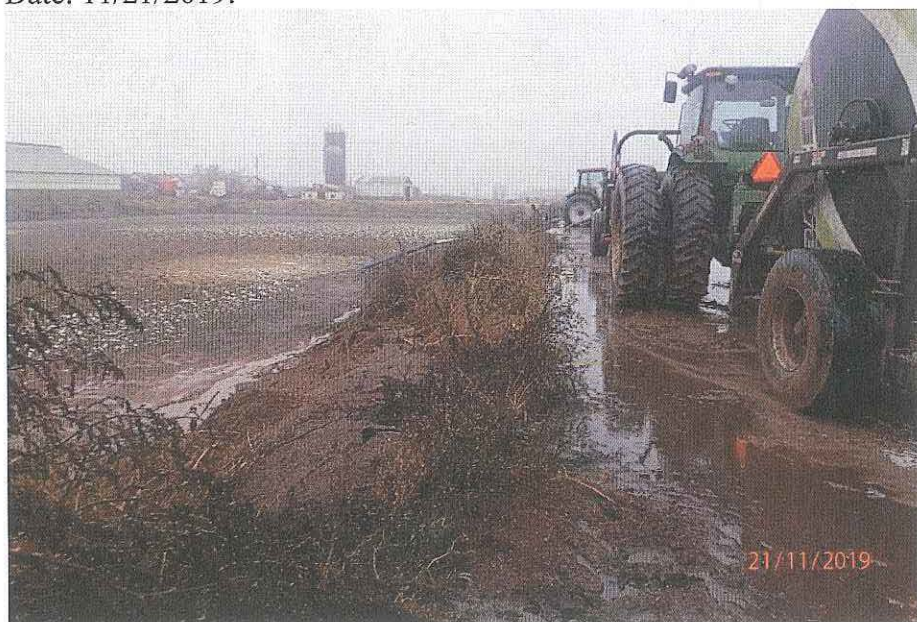
55: PB210017

Description: Solids are pushed off the Concrete Pad into Pit 1 or are pumped out of Pit 1 and stored on the Concrete Pad when preparing to land apply.

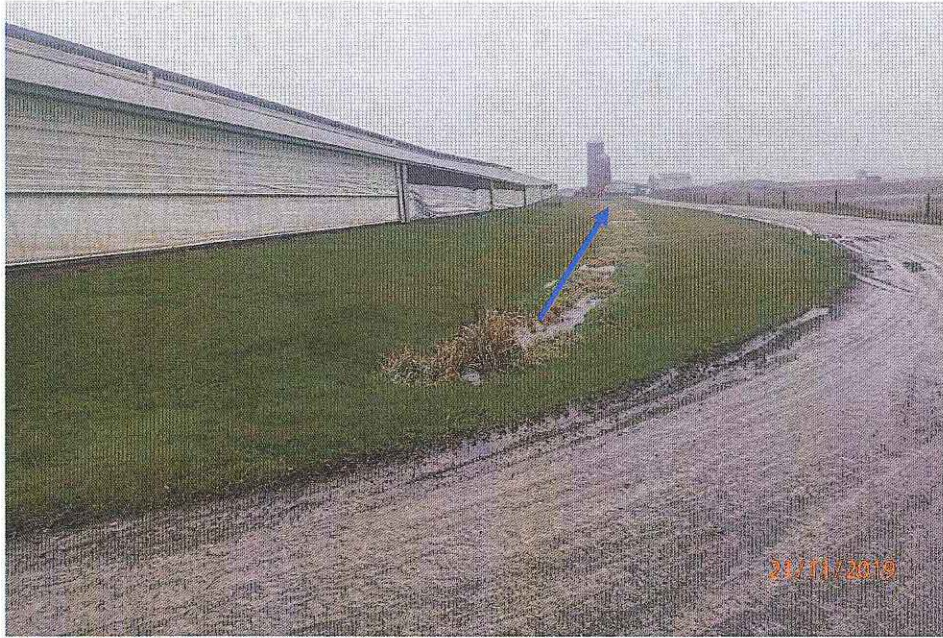
60: PB210022

EPA walked back along the East Access Road to the south and observed how clean water is diverted away from the Production Area along the east side of the Large Freestall Barn. Stormwater off the roofs of the barns and other buildings is conveyed through culverts into ditches on the south and east side of the South Site of Meadowlark Dairy, LLC. Depending on where the stormwater falls on the south side of the South Site, it will flow either east or west through culverts and then into ditches that are on the east and west side of the Large and Small Freestall Barns and flow by gravity to the north (PB210021-PB210023).

Description: The ditch on the east side of Large Freestall Barn conveys stormwater by gravity to north from the south side of the Large Freestall Barn and the Large Freestall Barn's roof (the blue arrow shows the direction of flow in the Stormwater Ditch above).

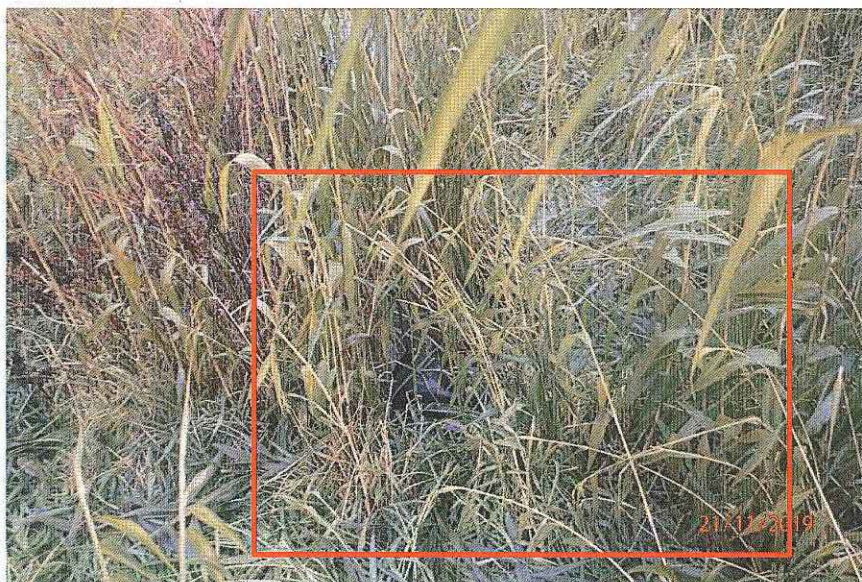
63: PB210025

into the Bedpack Barn. EPA observed stormwater mixed with used feed, bedding, and manure flowing off of the concrete apron into the vegetated area between the Large and Small Freestall Barn. EPA observed a channel conveying flow from the south side of the Bedpack Barn (PB210026) to the culvert inlet between the Large and Small Freestall Barns (PB210032).

Description: Culvert inlet (in the red box in the photo above) between the Large and Small Freestall Barns.

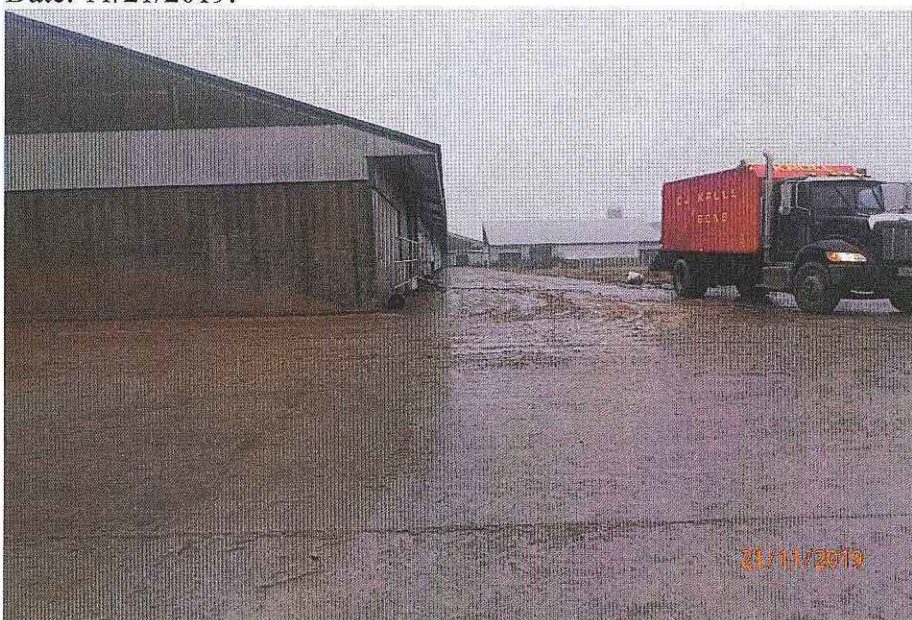
75: PB210037

Description: Truck traffic coming from the Small Freestall Barn.

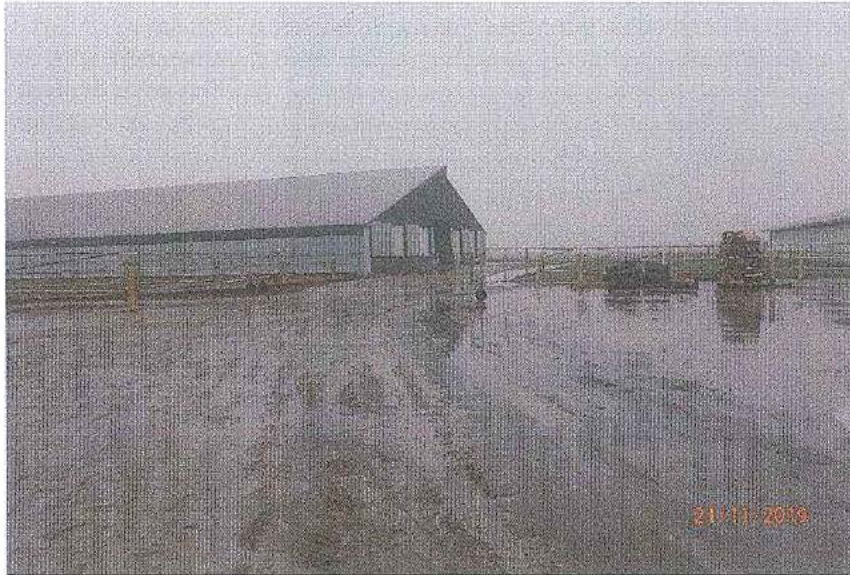
76: PB210038

Description: Track-in/track-out of used feed, manure, and bedding from vehicles going into the barns deposited onto the concrete apron south of the Large and Small Freestall Barns.

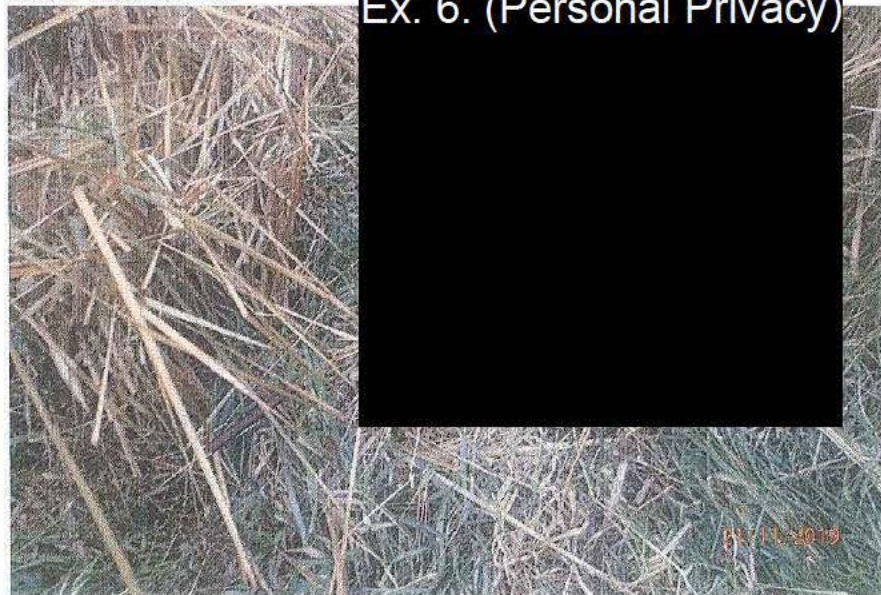
77: PB210039

Description: The culvert outlet discharges flow from the underground pipes connected to the culvert inlet between the Small and Large Freestall Barns into the West Stormwater Ditch west of the South Site.

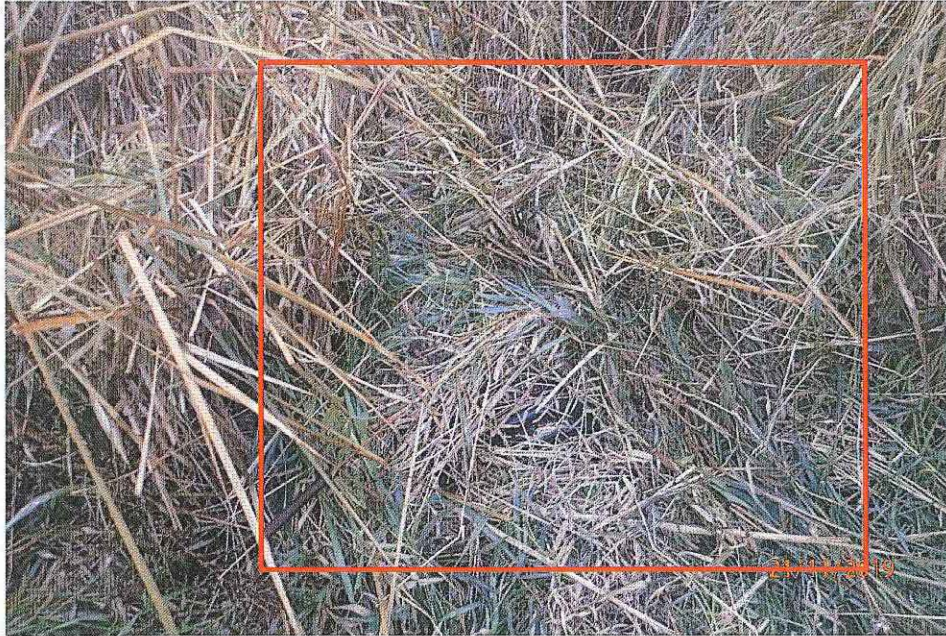
78: PB210040

Ex. 6. (Personal Privacy) showed EPA where the culvert outlet that conveyed the flow from the underground piping that was connected to the culvert inlet between the Large and Small Freestall Barns. EPA observed flow coming out of the culvert outlet and observed that the flow from the culvert flowed into the West Stormwater Ditch and flowed north (PB210040 -PB210042, PB210055 through PB210058, IMGP0001).

Description: Culvert outlets (in the red box in the photo above) into the West Stormwater Ditch.

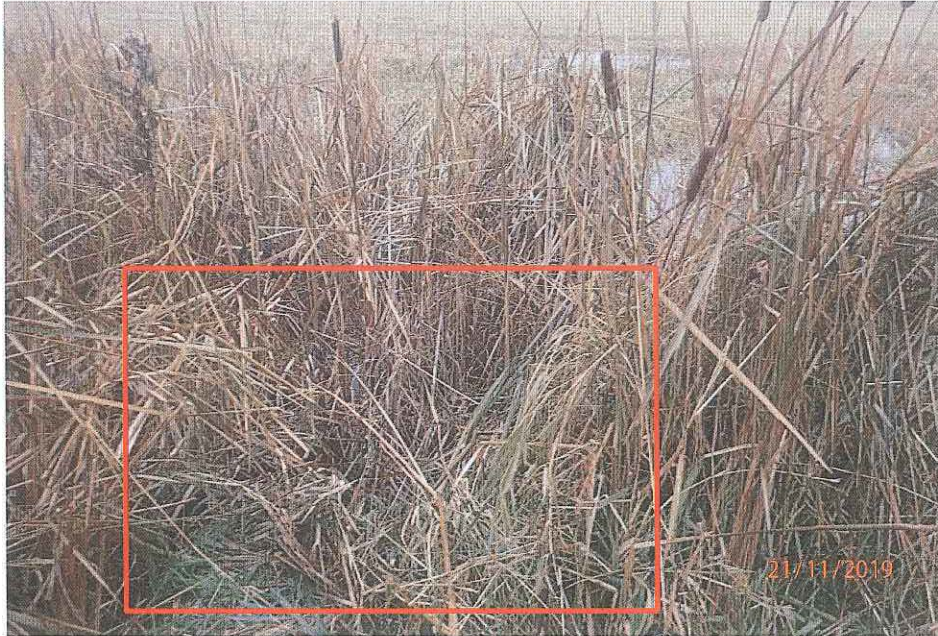
79: PB210041

Description: The culvert outlets (culvert outlet in the red box in the photo above) into the West Stormwater Ditch.

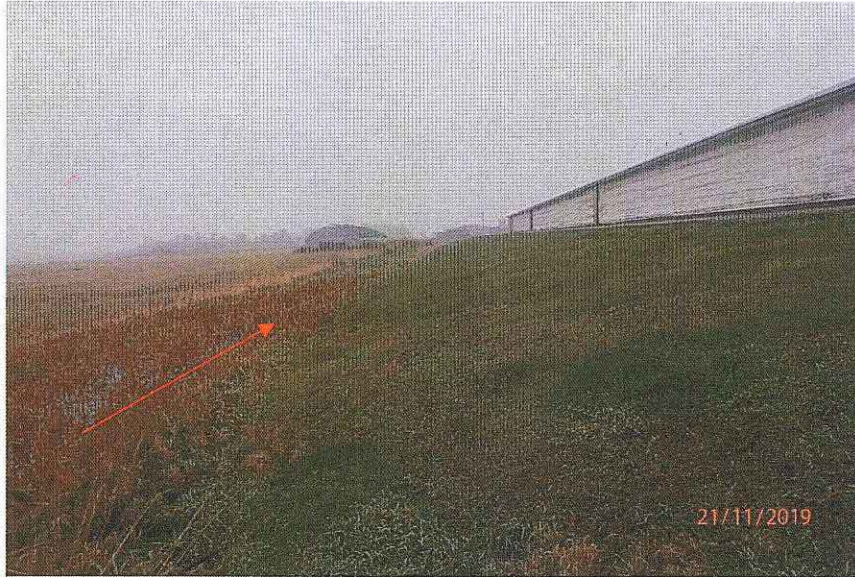
80: PB210042

Description: The red arrow shows the direction of flow in the West Stormwater Ditch. The flow from the culvert inlet between the Large and Small Freestall Barns flows through underground pipes to the culvert outlet discussed in photos 77: PB210039, 78: PB210040, and 79: PB210041 and flows into the West Stormwater Ditch.

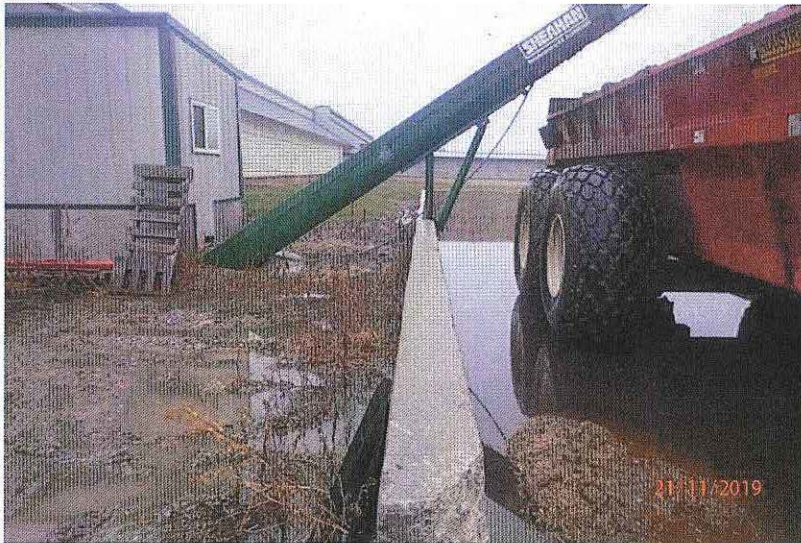
81: PB210043

Description: Clean out of the Calf Barn Pit.

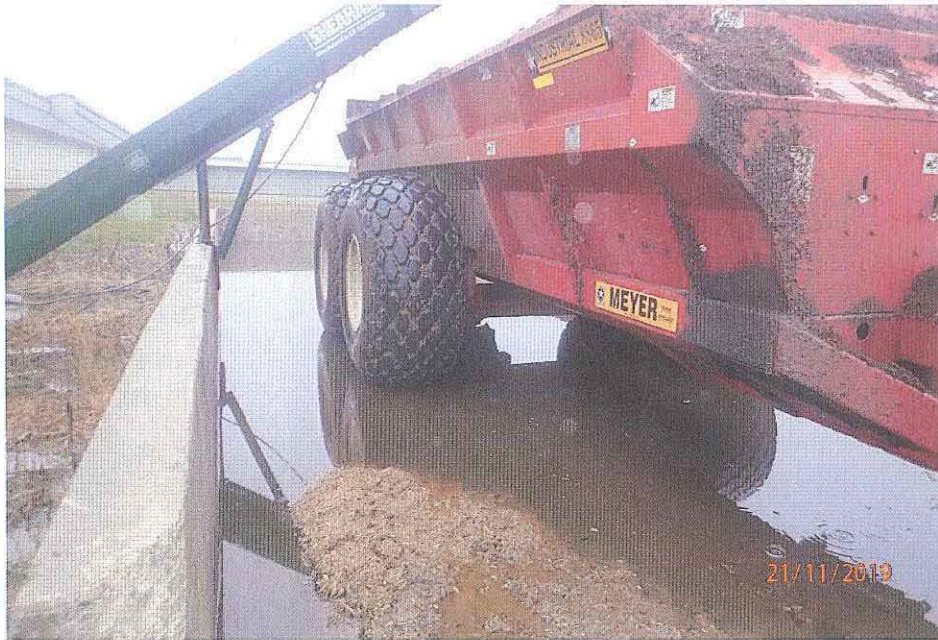
82: PB210044

Description: Loading of the manure from the Calf Barn pit.

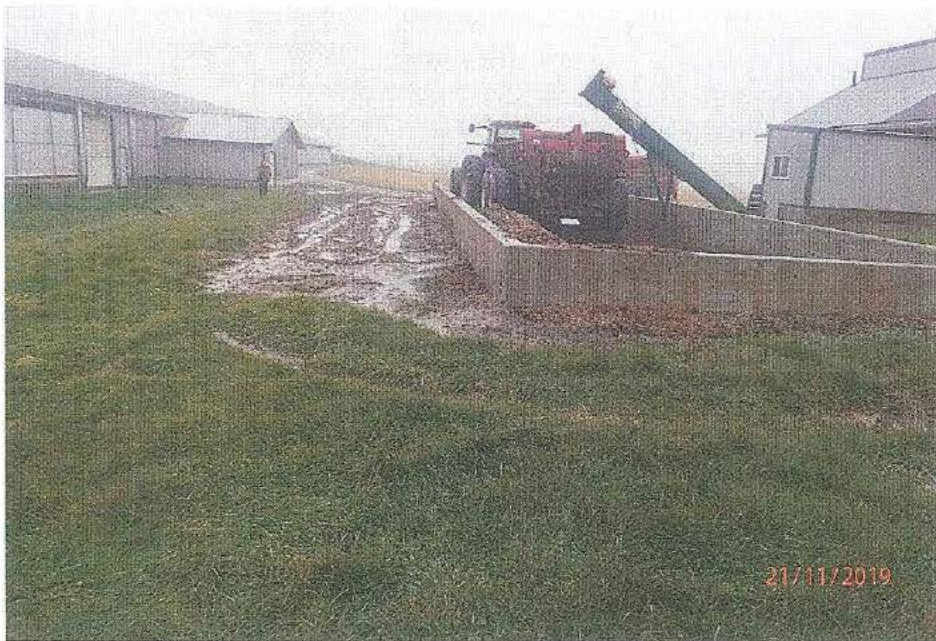
84: PB210046

Description: Containment area of the pump out of the Calf Barn pit.

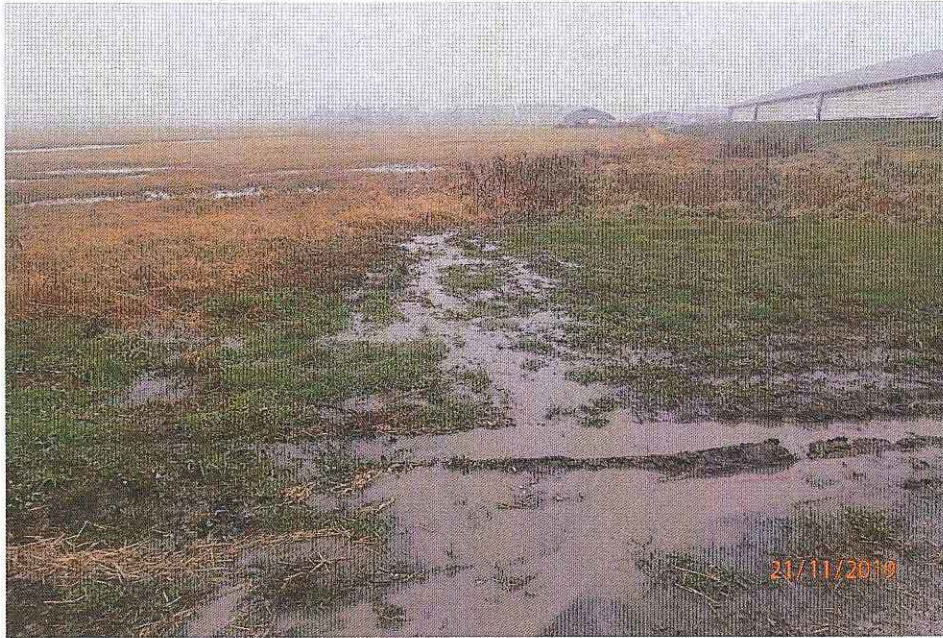
86: PB210048

Description: Stormwater from the north side of the Heifer Barn flows by gravity to the north into a crop field on the west side of the South Site.

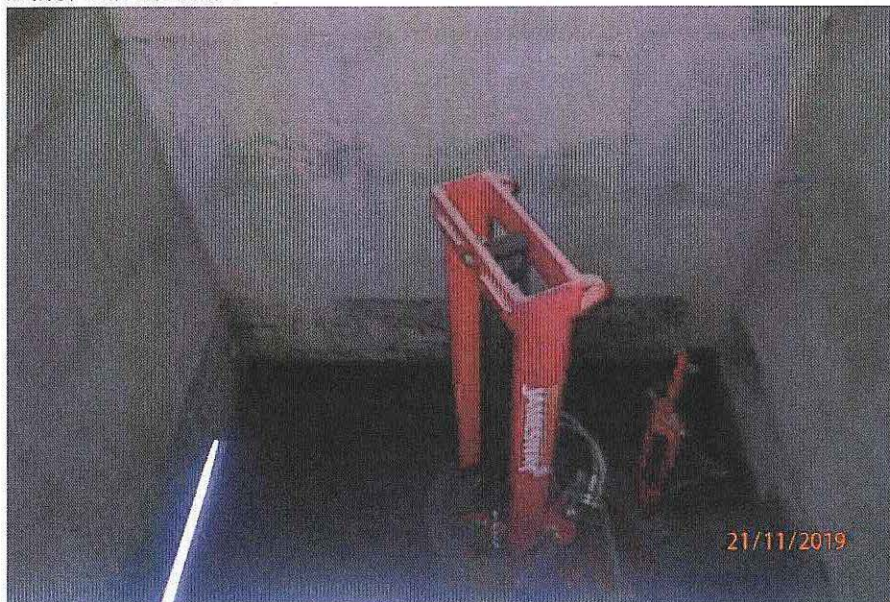
87: PB210049

Description: The pump and and pit for manure collected in the Heifer Barn.

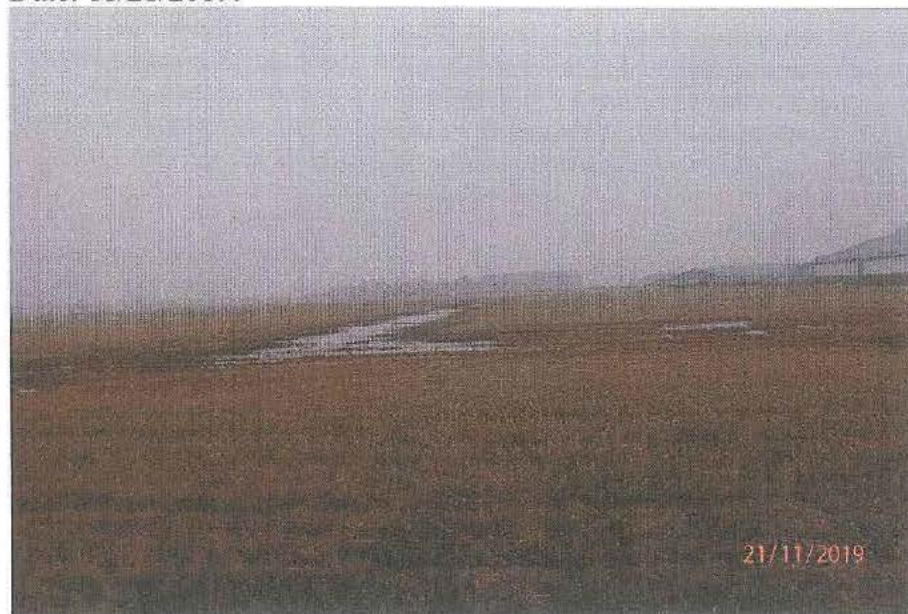
89: PB210051

Description: Crop field north of the Heifer Barn and West of the Small Freestall Barn.

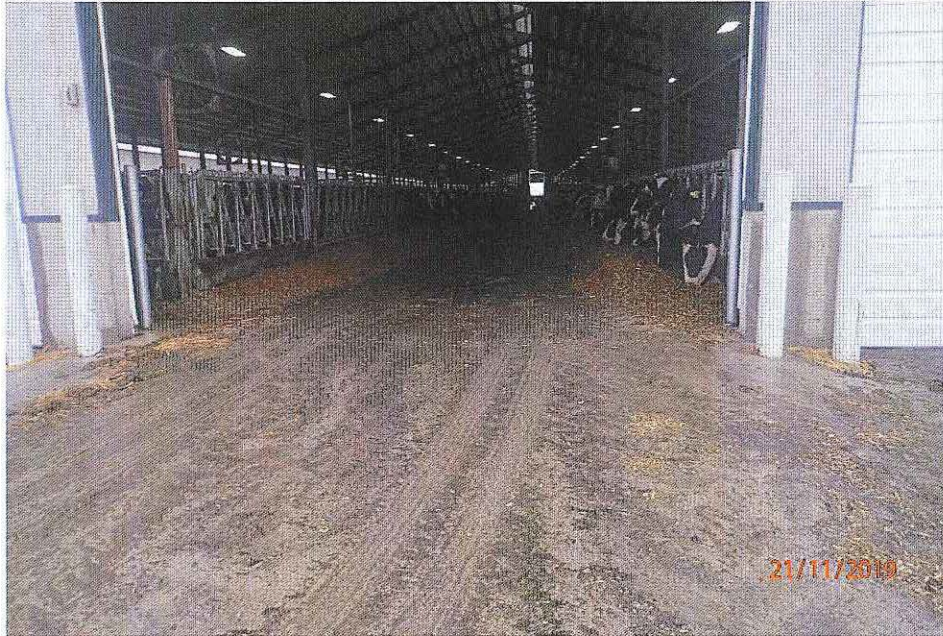
90: PB210052

Description: Inside the Heifer Barn. Track-in and track-out on the apron on the west side of the Heifer Barn.

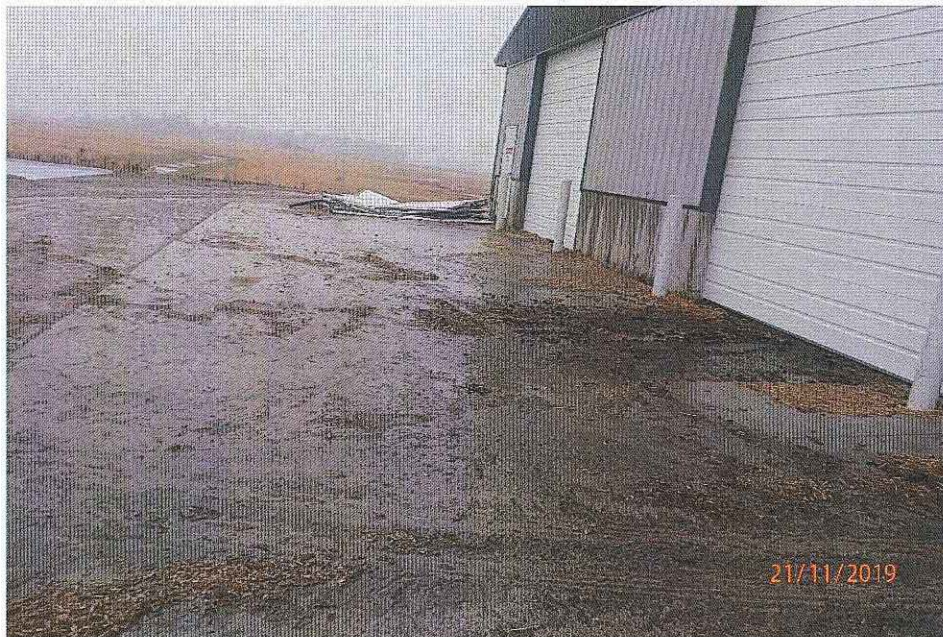
91: PB210053

Description: Track-in/track-out of used feed, manure, and bedding from the Heifer Barn.

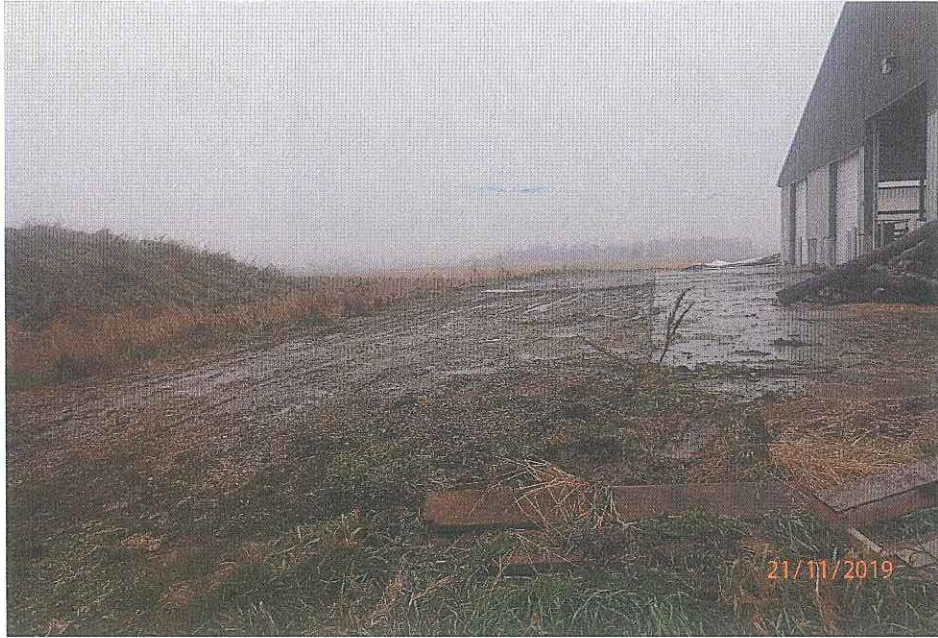
92: PB210054

Description: Track-in/track-out of used feed, manure, and bedding that had come into contact with the stormwater and was flowing off of the concrete apron toward the ditch, west of the Heifer Barn. A berm was on the east side of the ditch which prevented the process wastewater from flowing into the ditch.

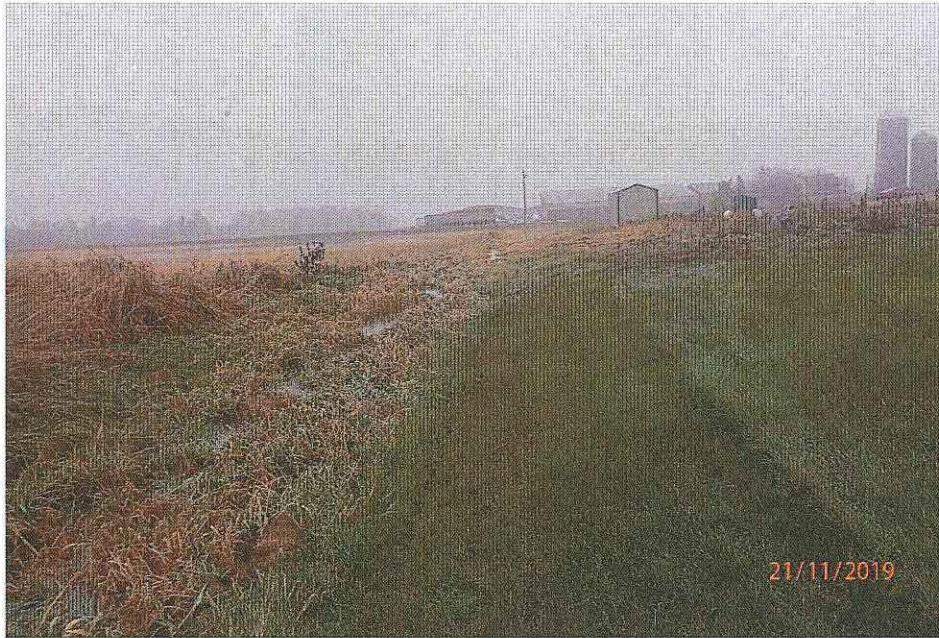
93: PB210055

Description: The West Stormwater Ditch that conveys flow by gravity to the north toward Meadowlark Road.

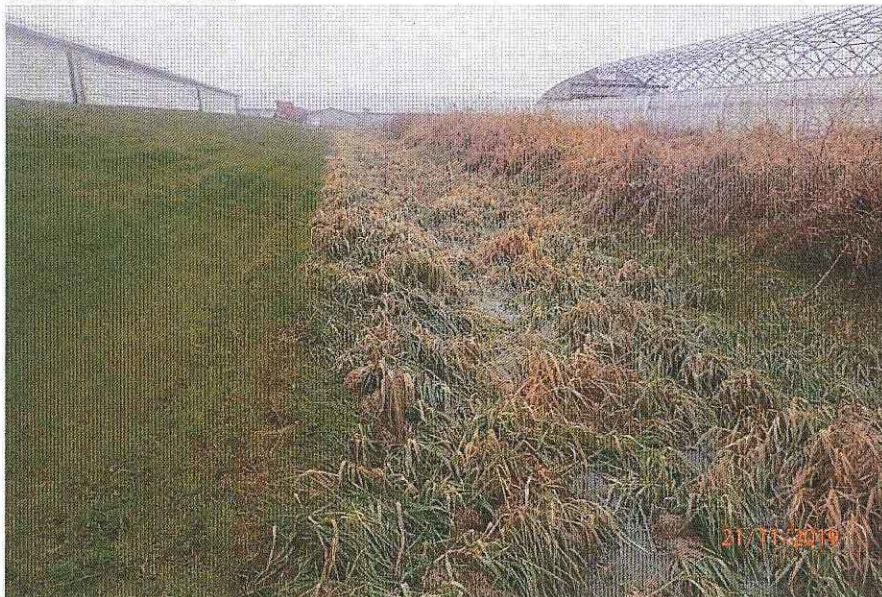
94: PB210056

Description: The West Stormwater Ditch that conveys flow by gravity to the north along the west side of the Small Freestall Barn on the South Site.

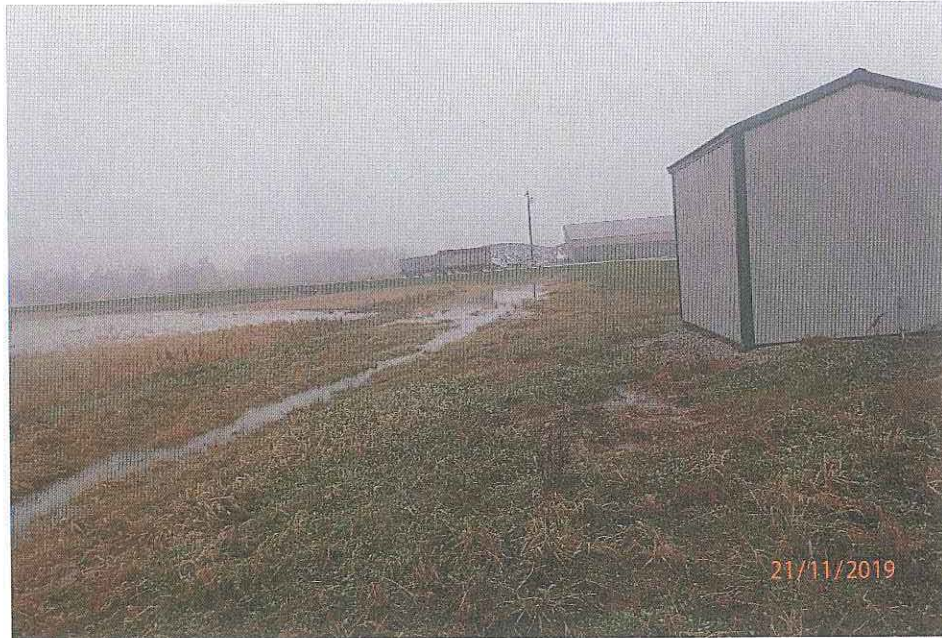
95: PB210057

Description: The West Stormwater Ditch that conveys flow by gravity to the north along the west side of the Small Freestall Barn on the South Site.

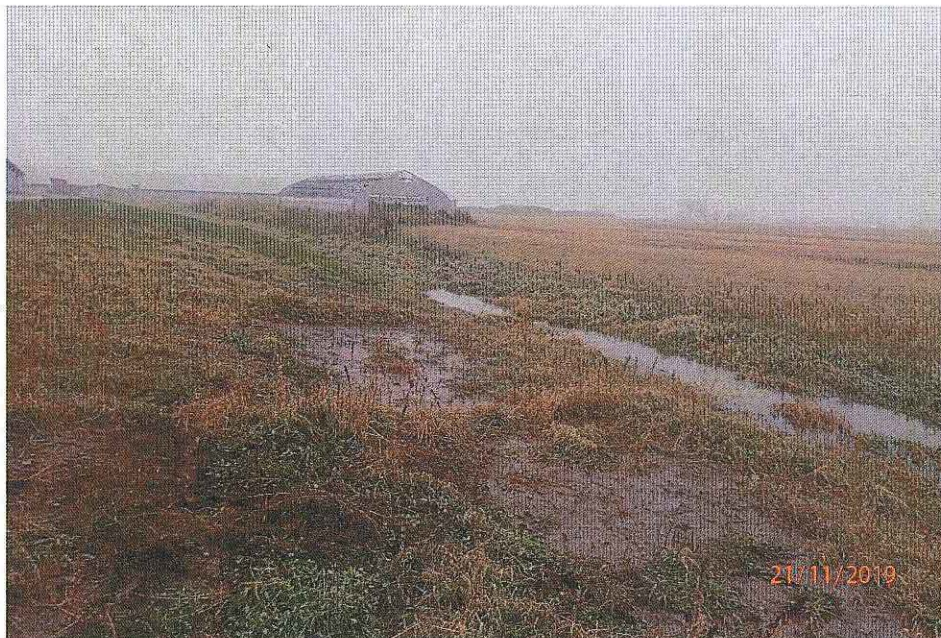
96: PB210058

Description: The West Stormwater Ditch that conveys flow by gravity to the north along the west side of the Small Freestall Barn on the South Site.
